NASA Contractor Report 165677

Investigation of the Effect of Resin Material on Impact Damage to Graphite/Epoxy Composites

R. J. Palmer

MCDONNELL DOUGLAS CORPORATION
Douglas Aircraft Company
Long Beach, California 90846

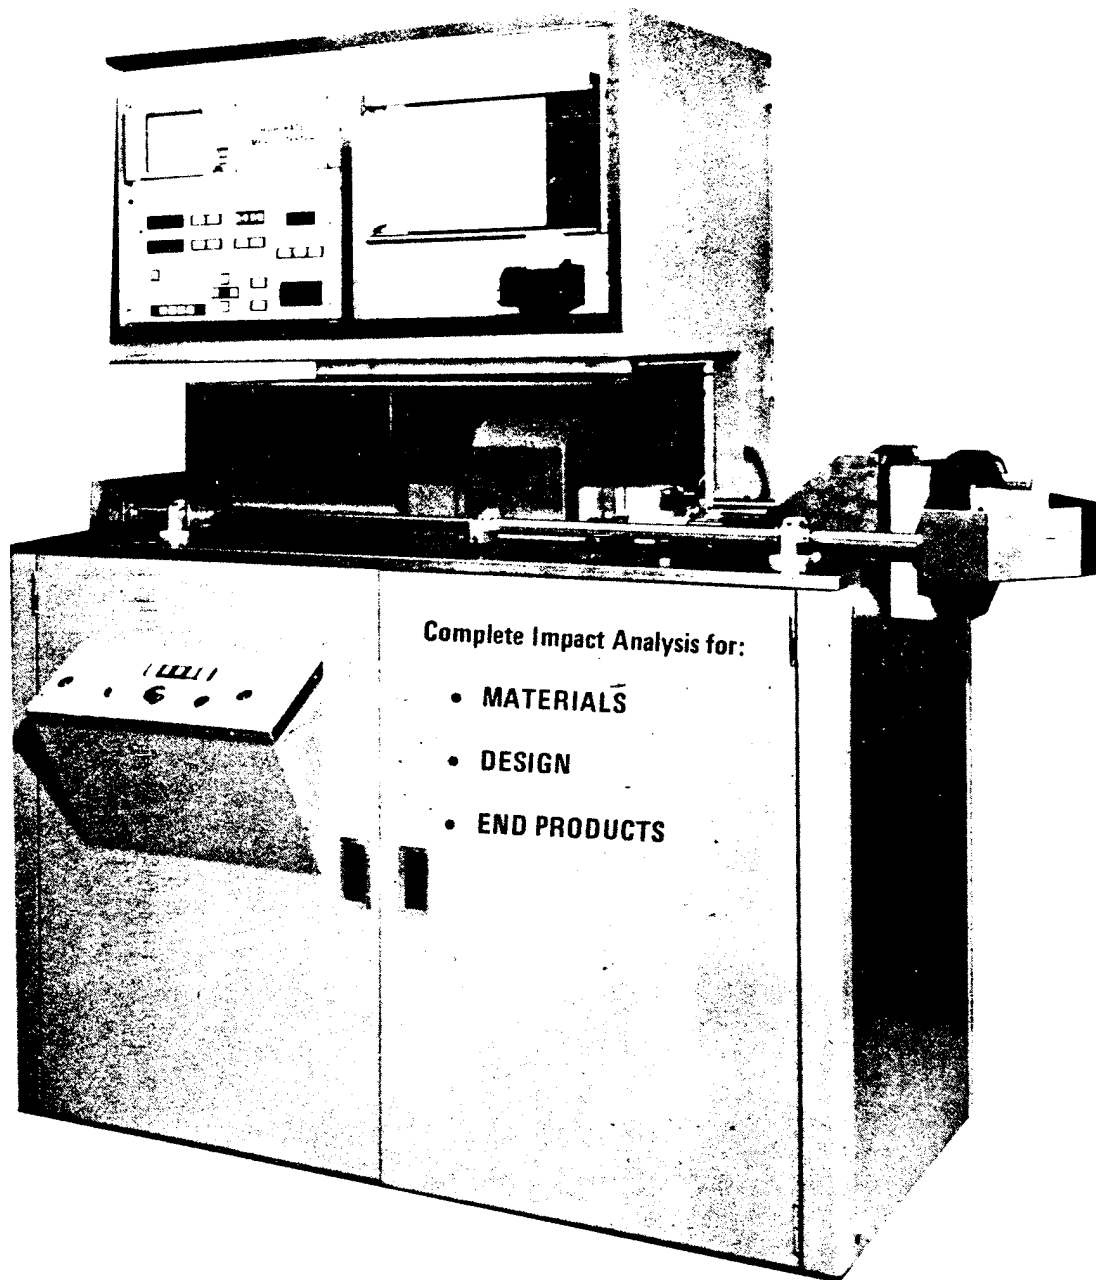
FIGURE 4. RHEOMETRIC CONSTANT SPEED IMPACT TESTER

The Rheometric Impact Tester gave another useful means of evaluation of the impact characteristics of the materials. The test machine gathered data during the test event, recorded a printed record of a load deflection curve, and calculated and printed the calculation of initial slope of the stress strain curve (which is a measure of the material modulus of elasticity), energy in joules (inch pounds), absorbed at first sign of failure, and the total energy absorbed, in joules (inch pounds), during the total test event.

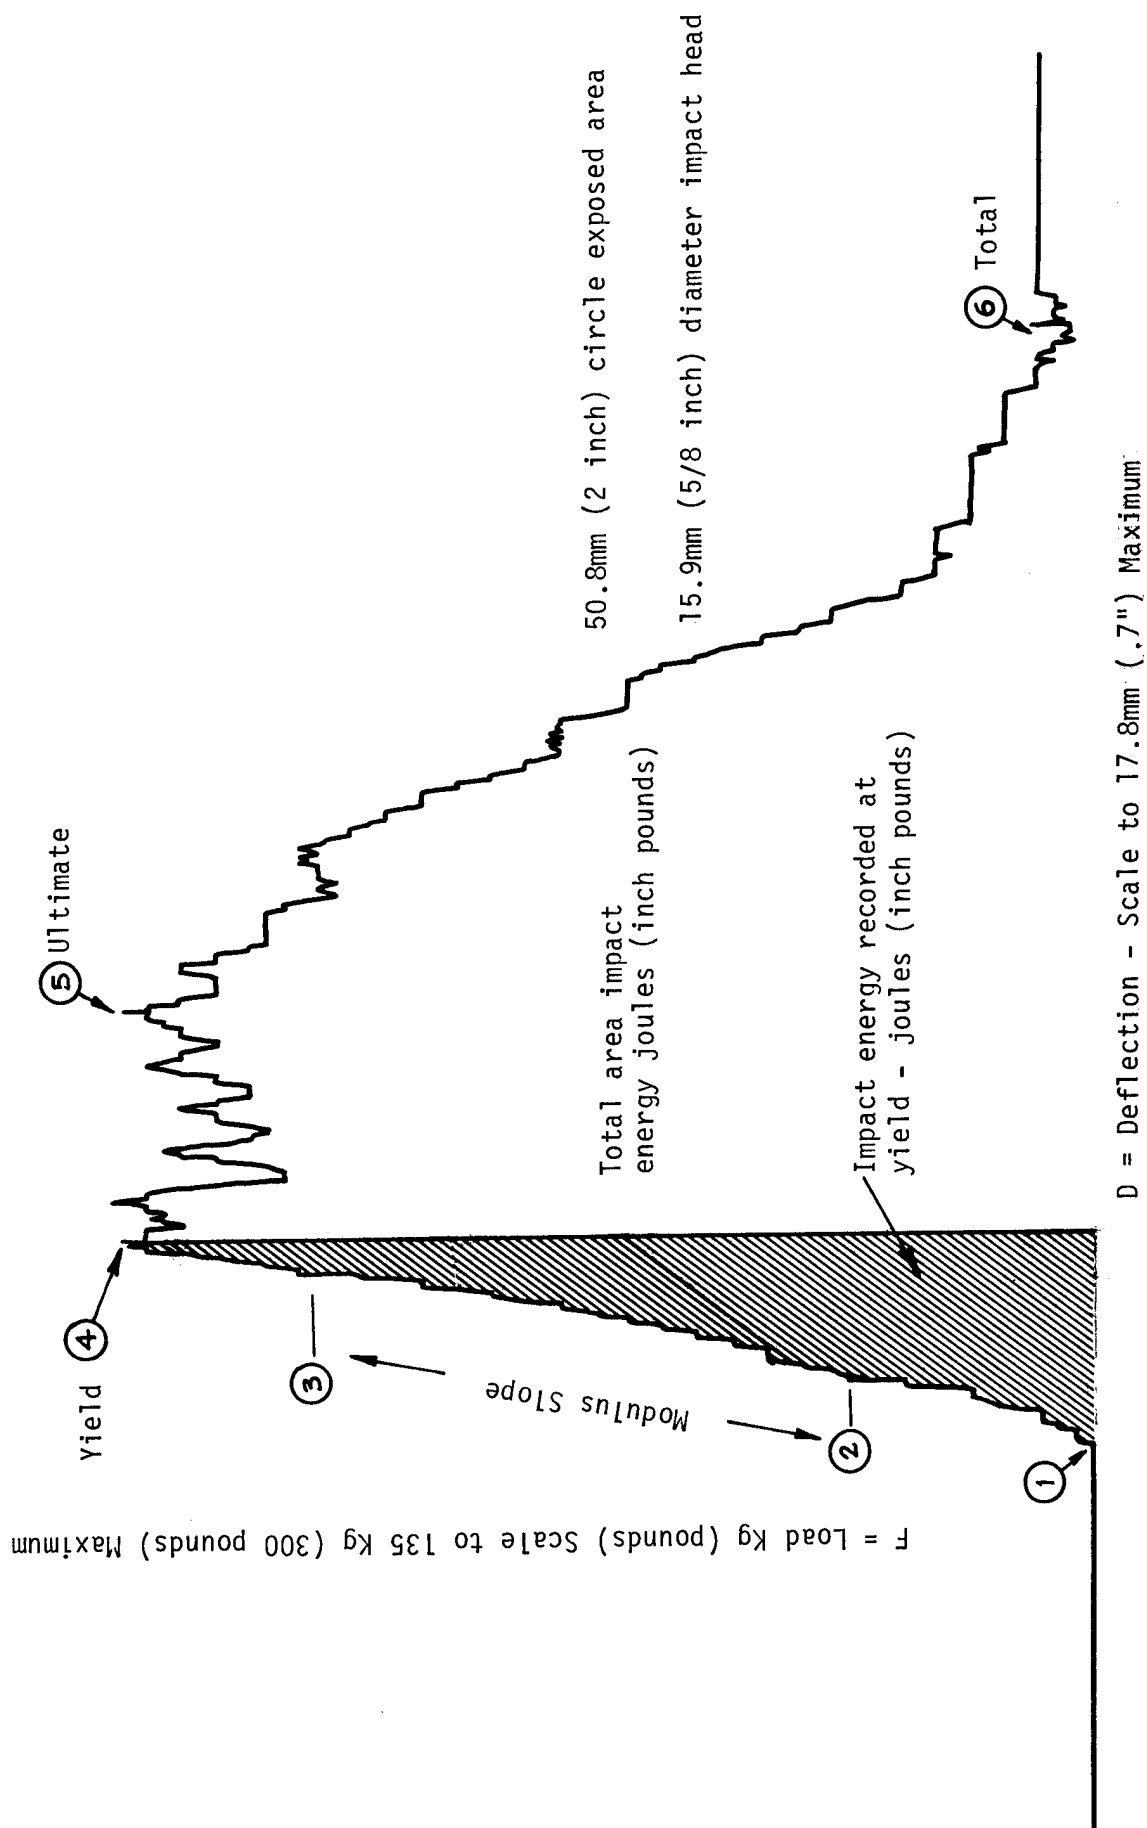
FIGURE 5. RHEOMETRICS CONSTANT SPEED IMPACT CHART

- (4). Yield is the time that the stress/strain deviates from an approximate straight line and is considered the point of initial impact damage to the specimen. The area, in joules (inch pounds), under the curve from point 1 to 4, is calculated as the energy absorbed at first sign of panel damage or failure.

A summary of the Rheometric calculations of slope of the stress-strain curve, energy absorbed at initial impact failure and total energy absorbed by impact penetration is shown in Table 4. Individual traces for the ten materials, studied are presented in Appendix 3.

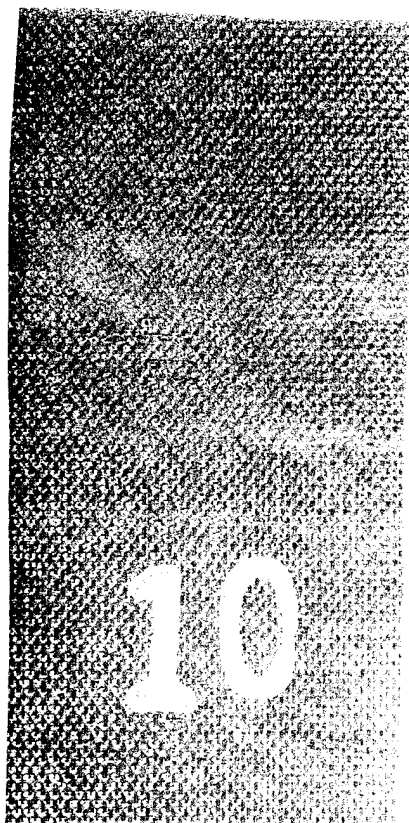
FIGURE 9. VISIBLE IMPACT DAMAGE ON BACK SIDE (0, \pm 45, 90)_s
5208 REFERENCE LAMINATE

(60 inch-pounds)
6.78 Joules

(80 inch-pounds)
9.04 Joules

Almost all of the materials evaluated proved to have superior thin laminate impact resistance compared to the baseline Narmco 5208/T-300 material. This was an encouraging result and verified that the material suppliers do have the technical knowledge and capability to improve the toughness of current composite materials. The amount of visible damage from the Gardner Impact Tester is recorded for both the impact side and the back side of each impact panel in Appendix 1. Appendix 1 also includes a record of the C-scan recordings of internal damage and other detail information on resin and laminate properties. Figures 9, 10, 11 12 and 13 show the visual evidence at 2x magnification of damage on the back side of the Narmco 5208/T-300 material and four "toughened" materials. Note that all of the toughened systems exhibit much less visible impact damage. In every case the visible damage is more extensive on the back side than the impact side of the panel as recorded in Appendix 1.

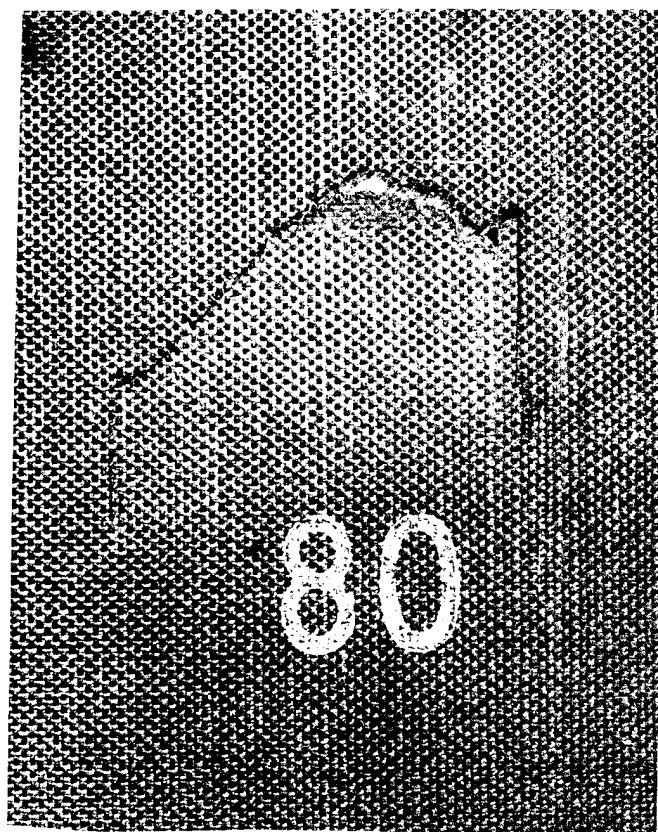
FIGURE 10. VISIBLE IMPACT DAMAGE ON BACK SIDE (0, \pm 45, 90)_s
HEXCEL #1 LAMINATE

(60 inch-pounds)
6.78 Joules

(80 inch-pounds)
9.04 Joules

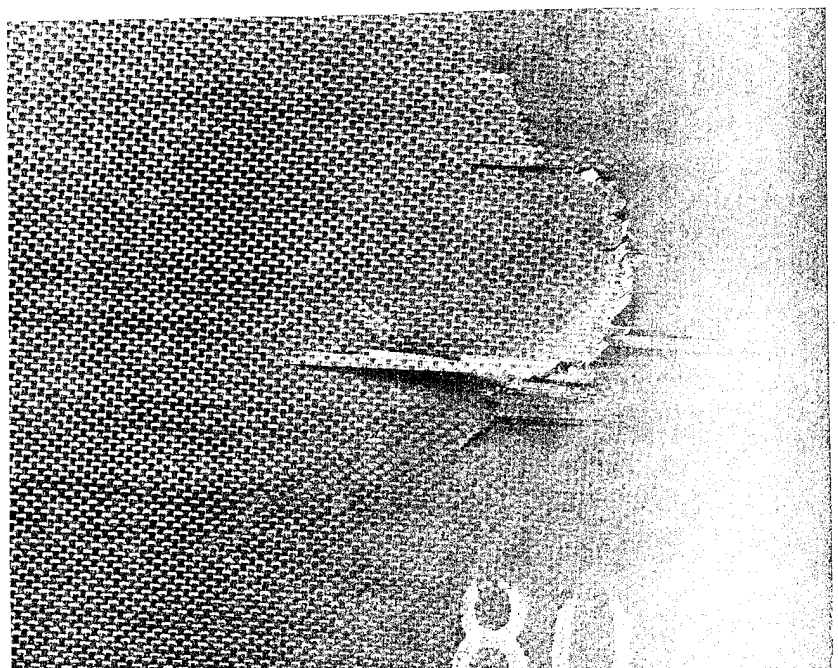
FIGURE 11. VISIBLE IMPACT DAMAGE ON BACK SIDE (0, \pm 45, 90)_s
CIBA GEIGY #4 LAMINATE

(60 inch-pounds)
6.78 Joules

(80 inch-pounds)
9.04 Joules

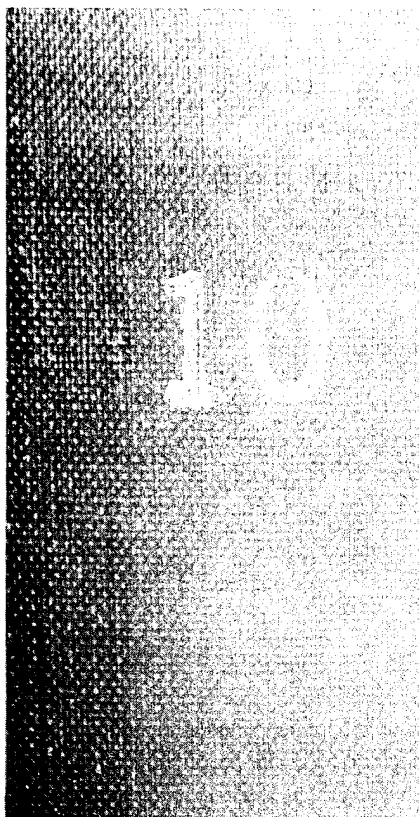
FIGURE 12. VISIBLE IMPACT DAMAGE ON BACK SIDE (0, \pm 45, 90)s
BP907 LAMINATE

(60 inch-pounds)
6.78 Joules

(80 inch-pounds)
9.04 Joules

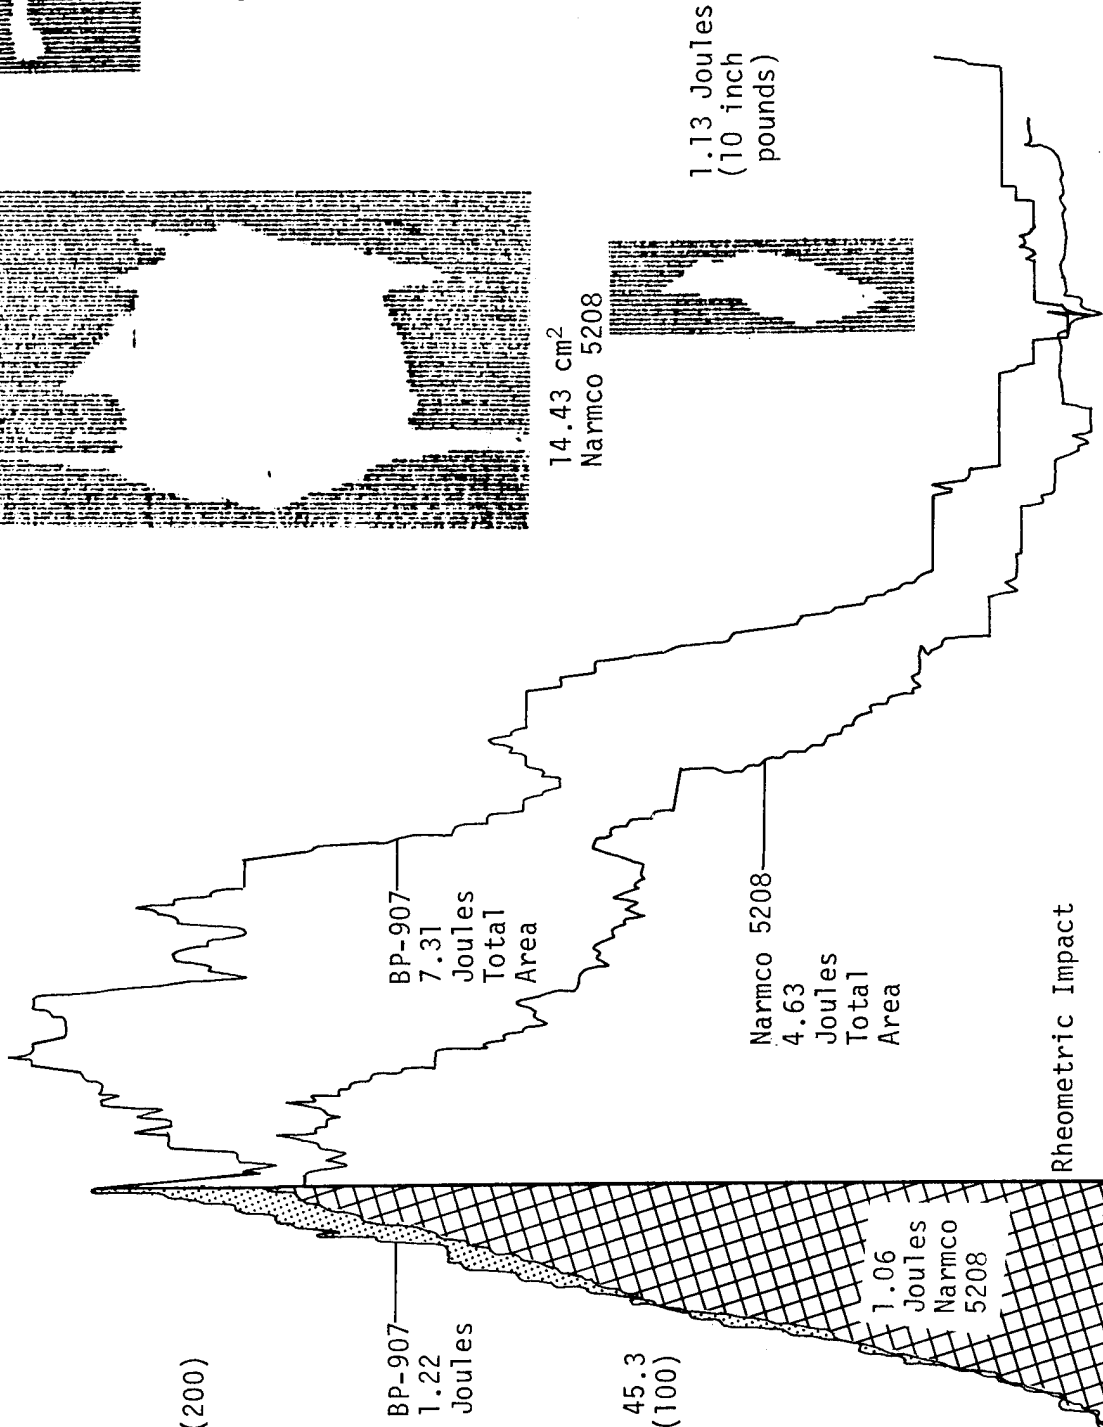
FIGURE 27. BP-907 VS NARMCO 5208 FOR RHEOMETRIC IMPACT AND GARDNER IMPACT AREA OF DAMAGE

Rheometric Impact

Total Deflection - Millimeters (inches)
